Vacuum Trucks Key to Successful Trench Rescue

BY STEVE WHITE

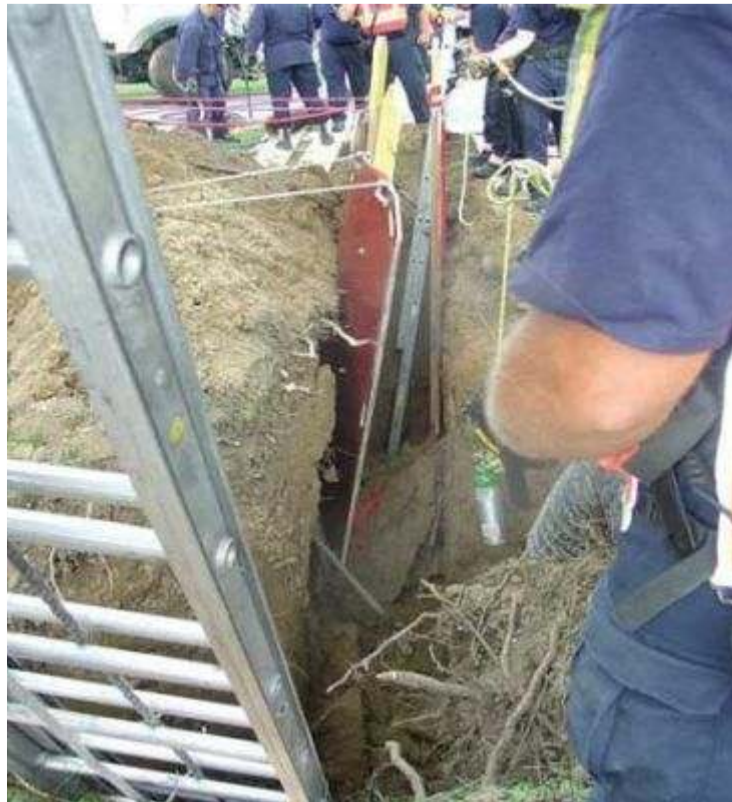
(1) The victim trapped in the V-void. [Photos by Division Chief Jim Alderman, Fishers (IN) Fire Department.]

The 35-year-old private contractor (the only victim) was attempting to tap a residential sewer line when he became trapped by a slough-in collapse. The only visible part of the victim was his right hand. A large section of clay that formed a V-void between the wall and the floor, which was partially supported by a shovel, covered his torso. The remainder of his body was buried to the nipple line of his chest. The victim stated he was in the standing position.

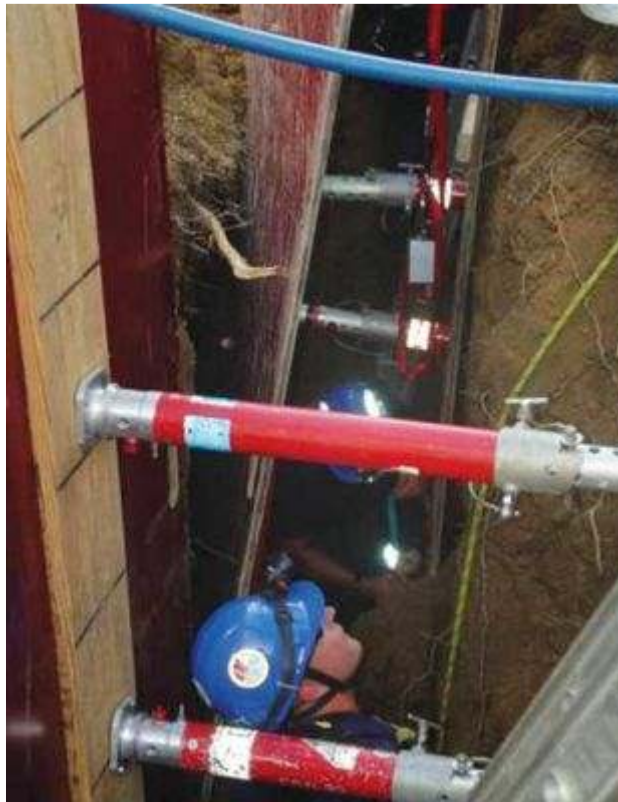
(2) A rescue medic starts an IV in a protected area.

The first set of panels was set next to the victim because of the large section of soil covering him. Our smallest air shores were used to secure the first set of panels. From the first set of secured panels that created the initial safe zone, the FFD rescue medic conducted an assessment, obtained baseline vitals, and established an IV. The victim answered questions appropriately and complained of back and leg pain.

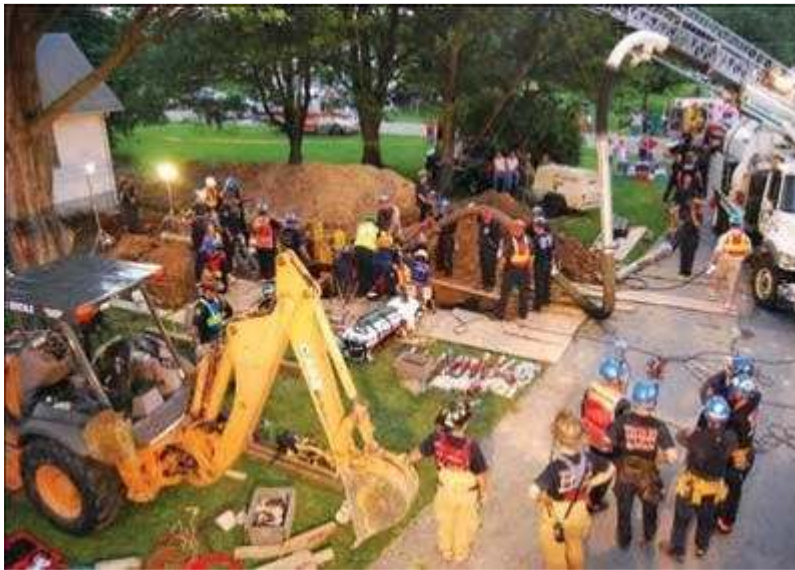
(3) HCTRT members operate the rescue vacuum system.

The city vacuum truck arrived, and members of the CFD assembled the vacuum system. The remainder of the trench lip was made safe with sections of the spoil pile removed by the rescue vacuum. HCTRT members supported a one-inch water line at one end of the trench. The second vacuum truck arrived and was staged as a backup.

A combination of folding shovels and an air knife was used to break up the soil to be removed by the rescue vacuum. Rescuers carefully removed the large section of clay positioned directly over the victim and creating the V-void. This section was estimated to be 300 pounds. Once this section was removed, rescuers were then able to focus on the soil trapping the victim to the nipple line.

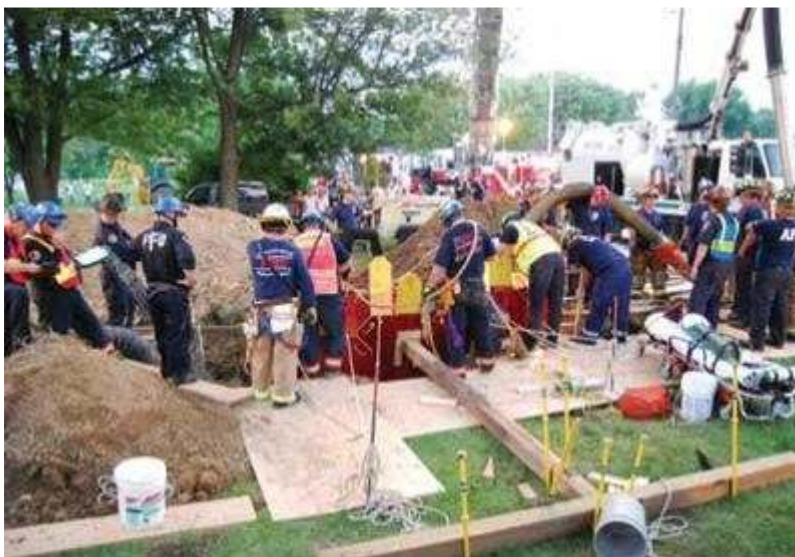
(4) The buttress system as part of the shoring plan.

Two additional panel sets were installed to gain working room. Since a section of the lip and the wall were missing, a buttress system was built to create a contact point behind one of the panels to ensure positive contact with the shoring system. The buttress was used in lieu of traditional “outside wales,” since the width of the trench was limited. Two 24-inch low-pressure air bags were used to take up void spaces between two separate panels and maintain positive contact in the shoring system.

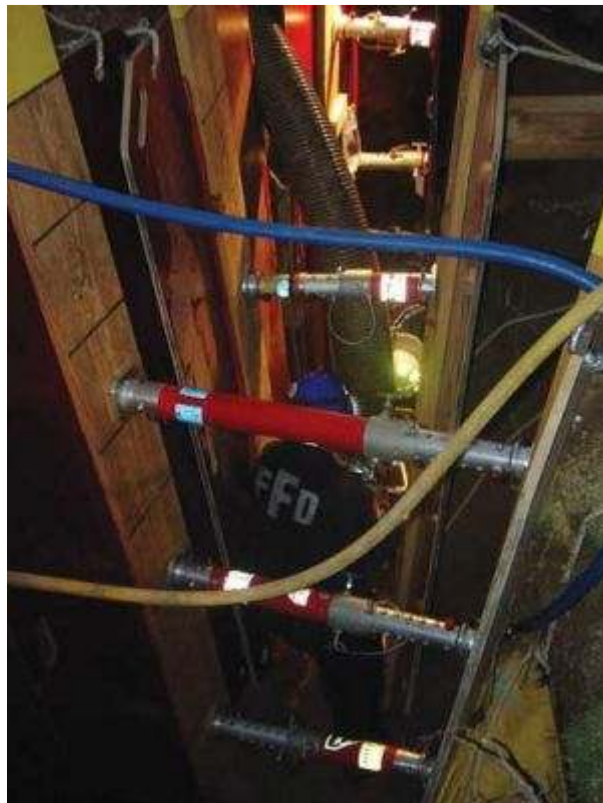
(5) The rescuers remove soil from the victim with the rescue vacuum and the air knife
